| <b>Project Name:</b><br>Gold King Mine | <b>Site Location:</b><br>Silverton, San Juan County, Colorado | <b>Project No.</b><br>0001/1408-01 |

## PHOTOGRAPH LOG

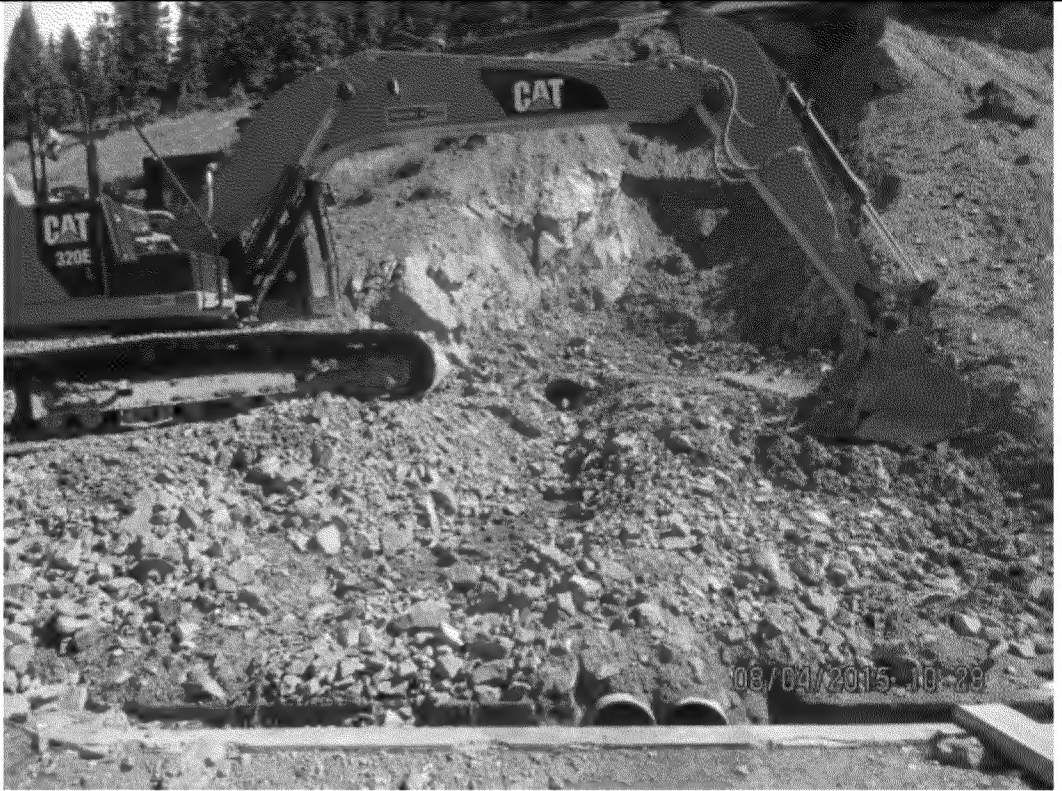
| <b>Photo No.</b><br>1 | <b>Date:</b><br>08/04/2015 | |

| <b>Description:</b><br>Beginning investigation into collapsed adit. | | |

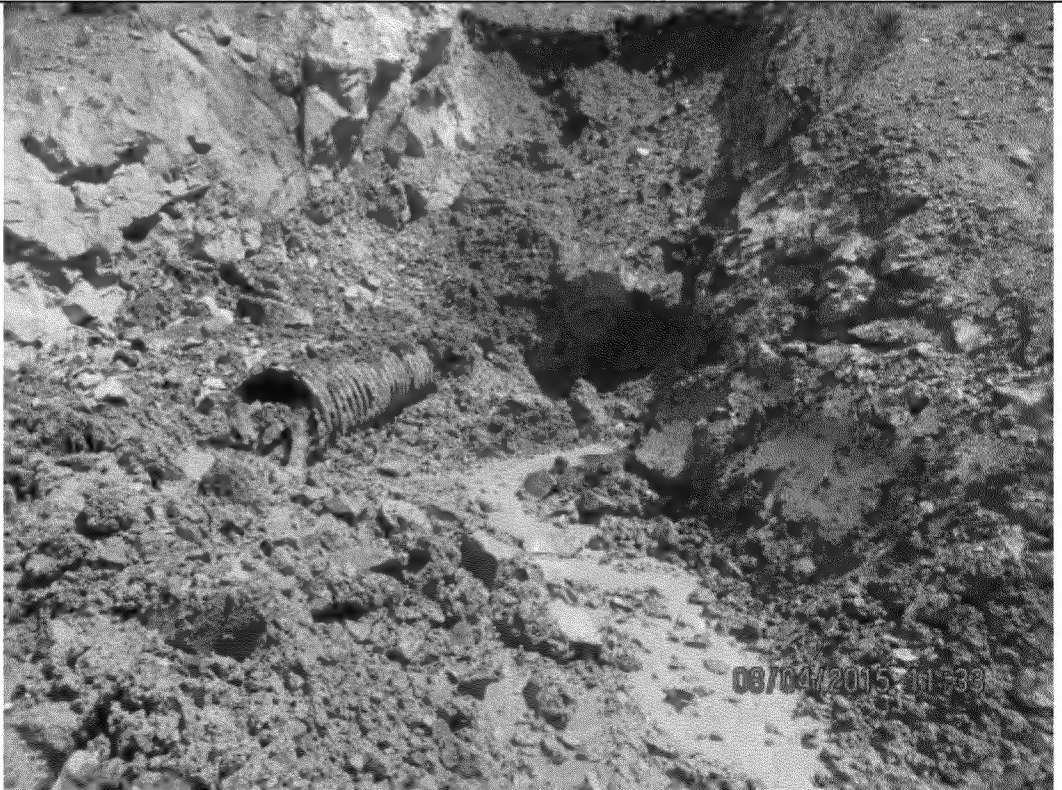
| <b>Photo No.</b><br>2 | <b>Date:</b><br>08/04/2015 | |

| <b>Description:</b><br>Excavated next to DRMS-installed culvert, water muddy from soil disturbance. | | |

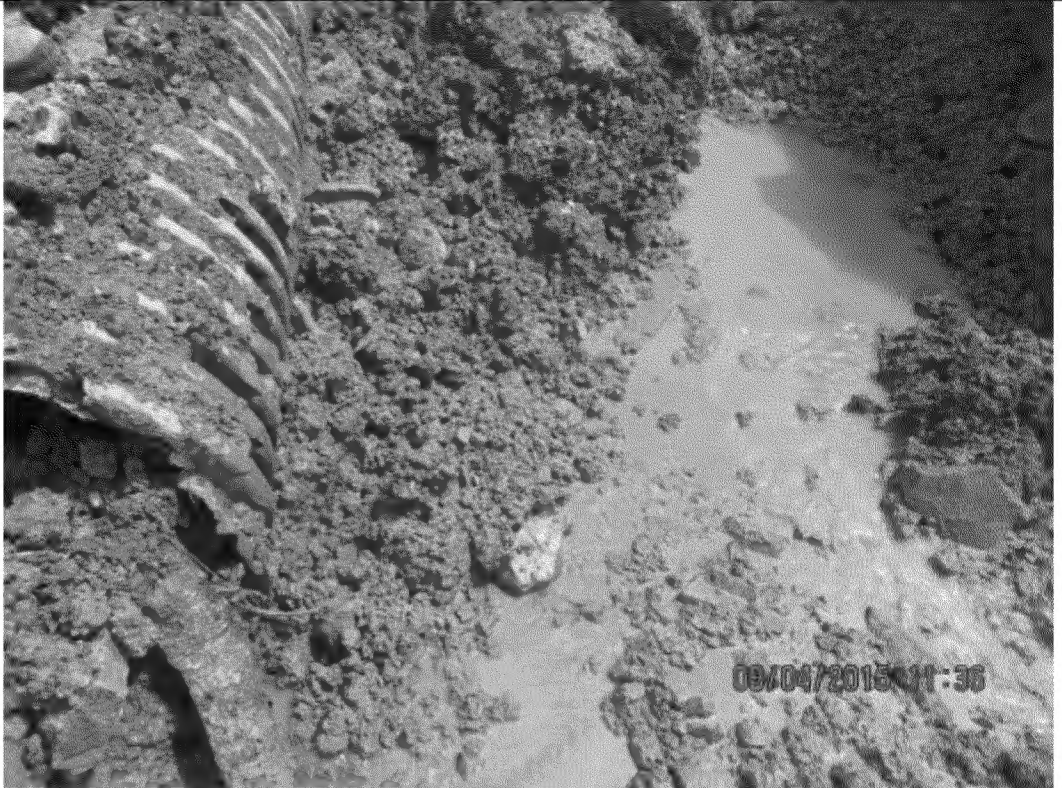
| <b>Photo No.</b><br>3 | <b>Date:</b><br>08/04/2015 | |

| <b>Description:</b><br>Seepage from soil next to piping. | | |

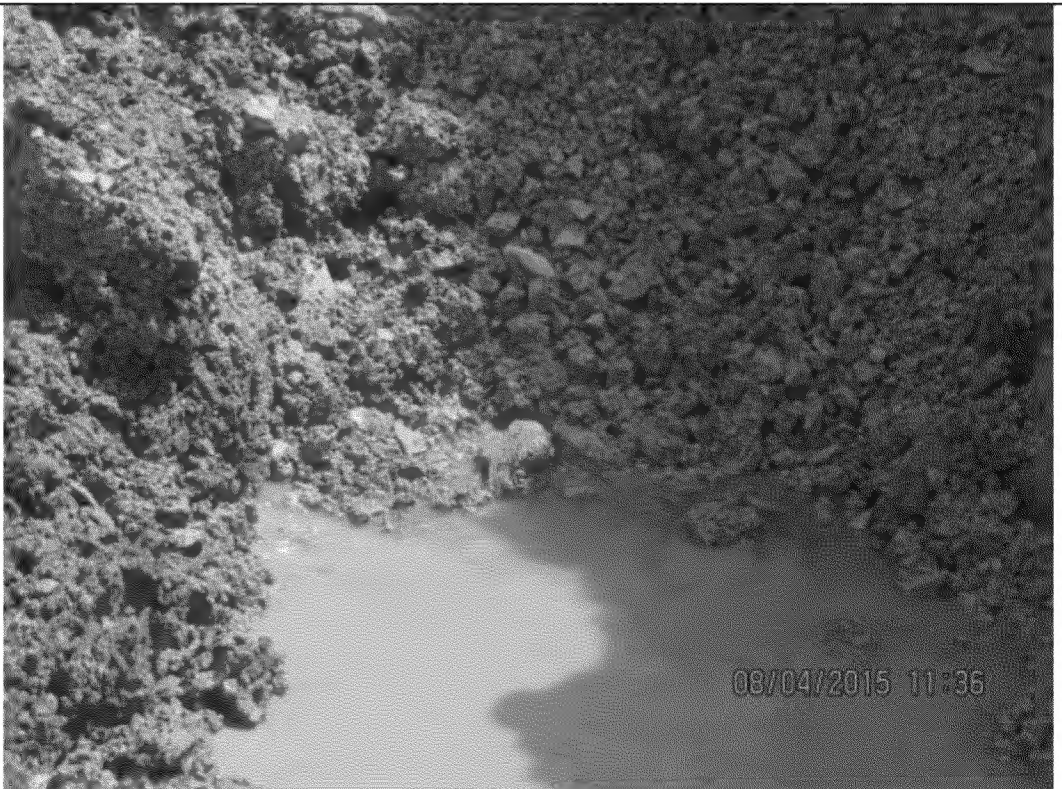
| <b>Photo No.</b><br>4 | <b>Date:</b><br>08/04/2015 | |

| <b>Description:</b><br>Seepage next to the pipe is clear until entering disturbed soil. | | |

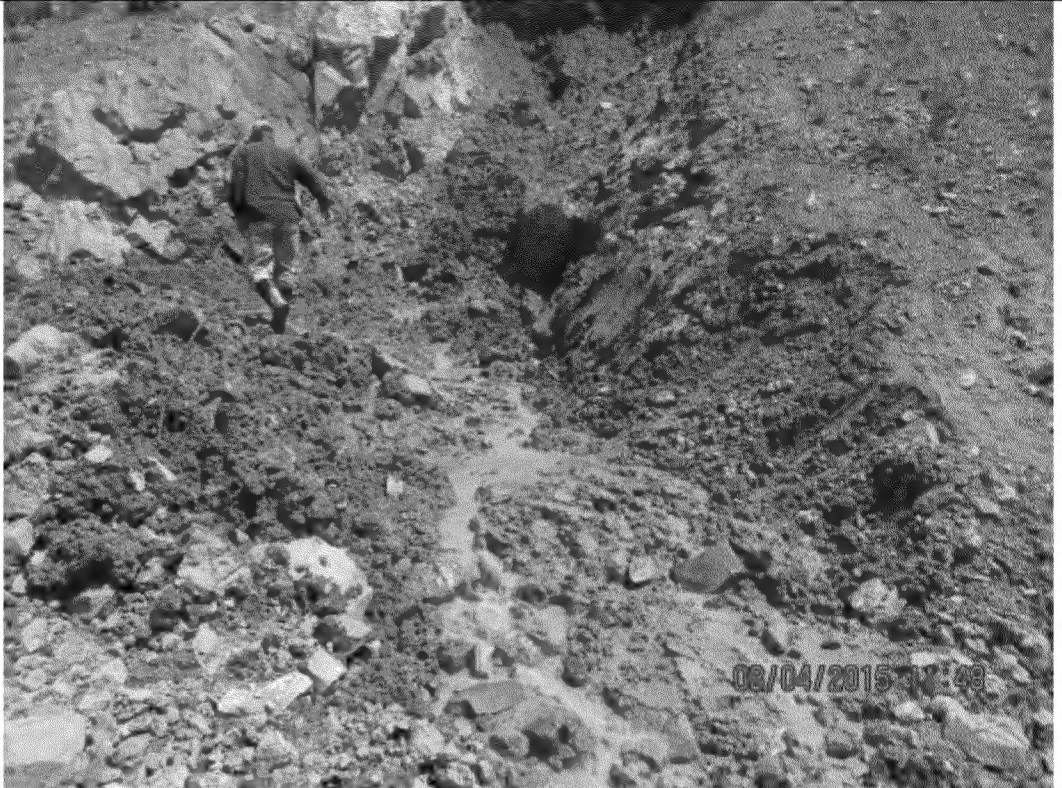
| <b>Photo No.</b><br>5 | <b>Date:</b><br>08/04/2015 | |

| <b>Description:</b><br><br>DRMS looking at adit excavation progress. | | |

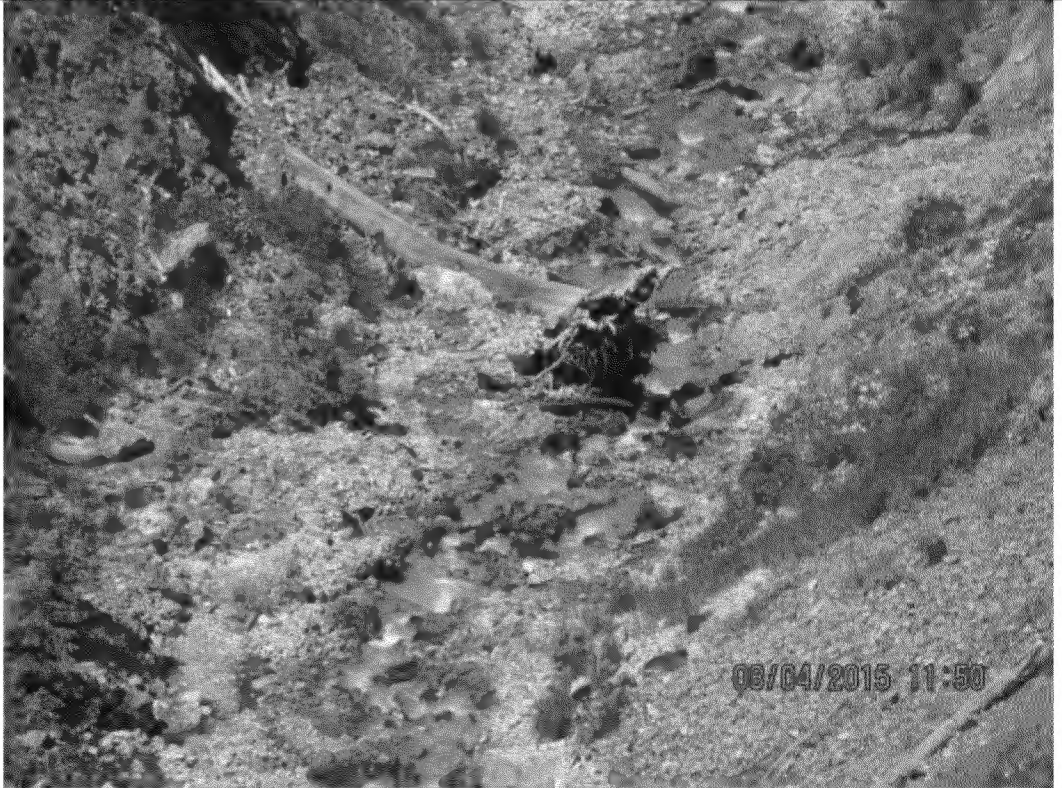
| <b>Photo No.</b><br>6 | <b>Date:</b><br>08/04/2015 | |

| <b>Description:</b><br><br>Water minimally murky from disturbed soil and water entering the North Fork from site. | | |

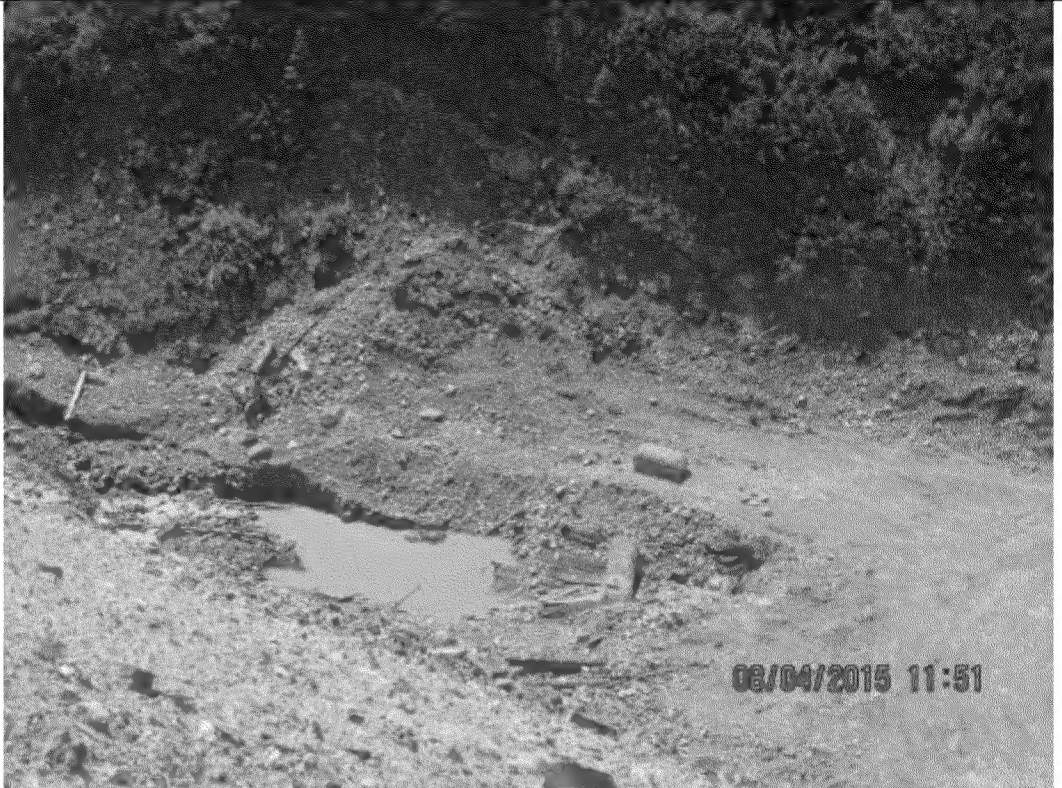
| <b>Photo No.</b><br>7 | <b>Date:</b><br>08/04/2015 | |

| <b>Description:</b><br>Hay bales installed as filter for sediment in North Fork. | | |

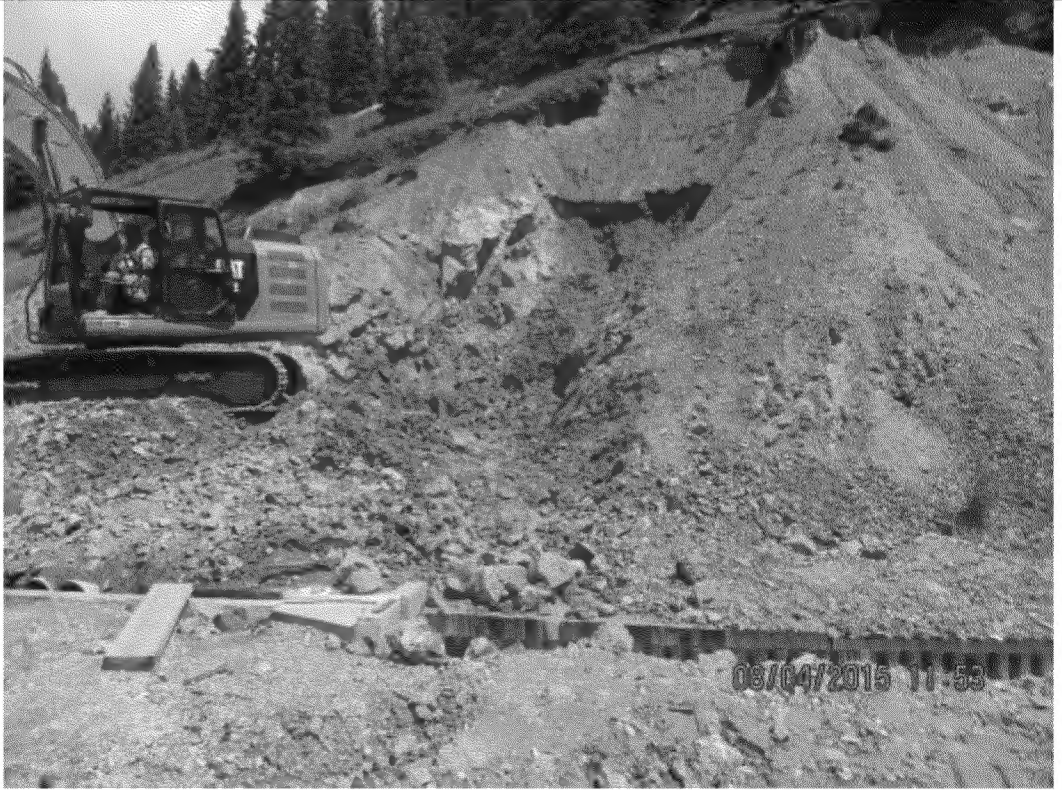
| <b>Photo No.</b><br>8 | <b>Date:</b><br>08/04/2015 | |

| <b>Description:</b><br>Continuing excavation at the collapsed adit, no solid bedrock found for tunnel support. | | |

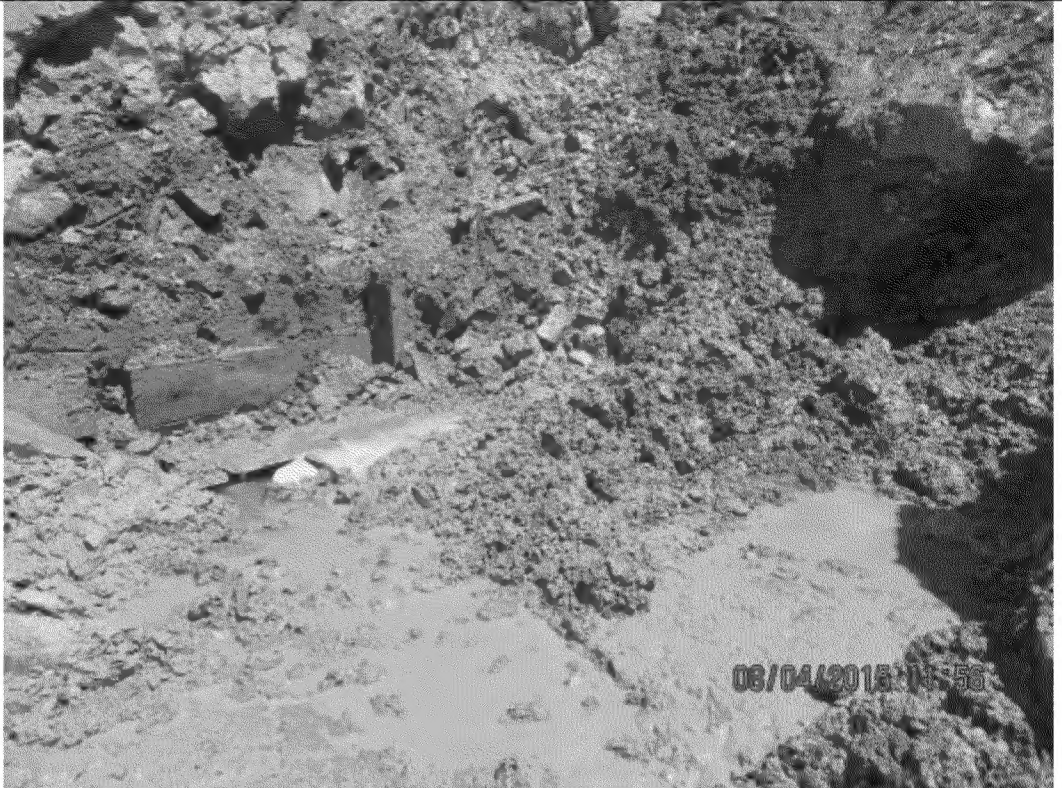
| <b>Photo No.</b><br>9 | <b>Date:</b><br>08/04/2015 | |

| <b>Description:</b><br>First signs of adit, support pillar with lagging. | | |

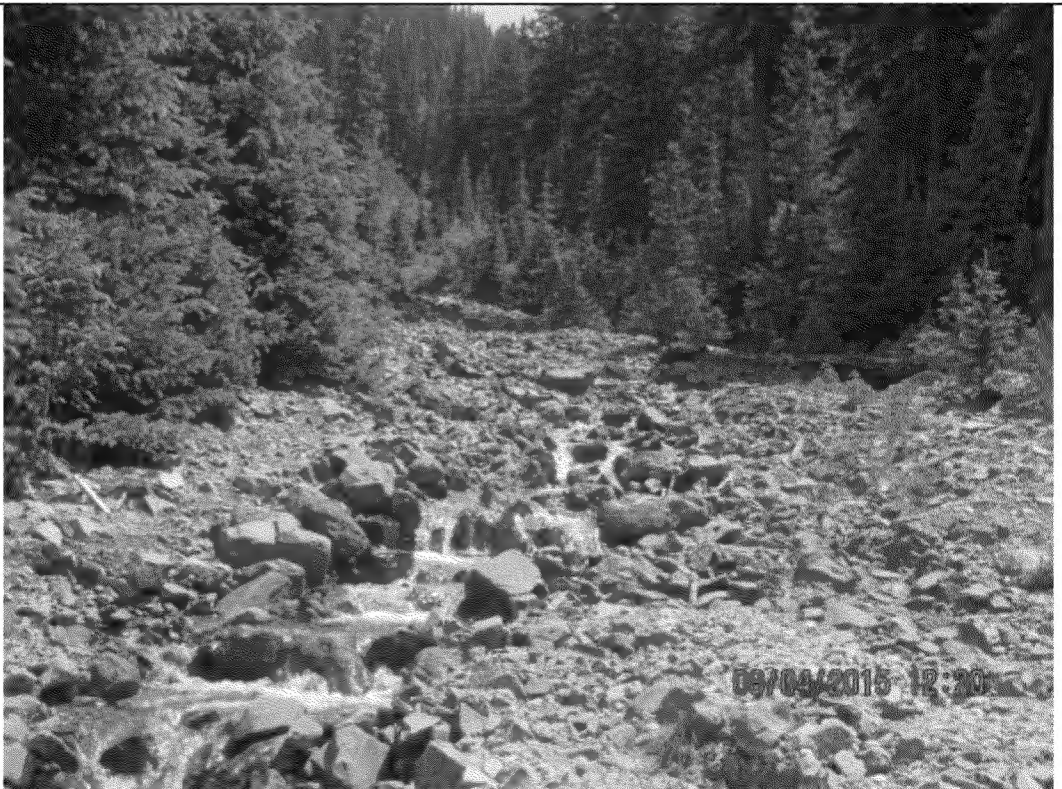
| <b>Photo No.</b><br>10 | <b>Date:</b><br>08/04/2015 | |

| <b>Description:</b><br>Water of the North Fork just upstream of Cement Creek. | | |

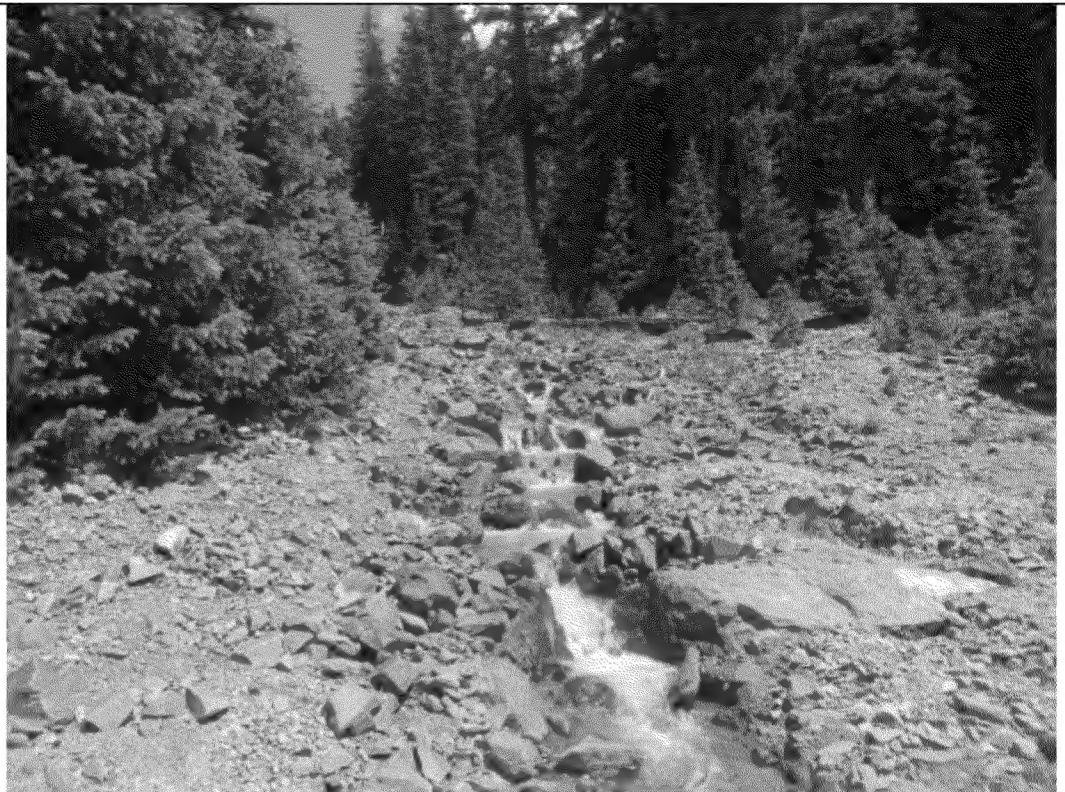
**11**

Water of the North Fork just upstream of Cement Creek.

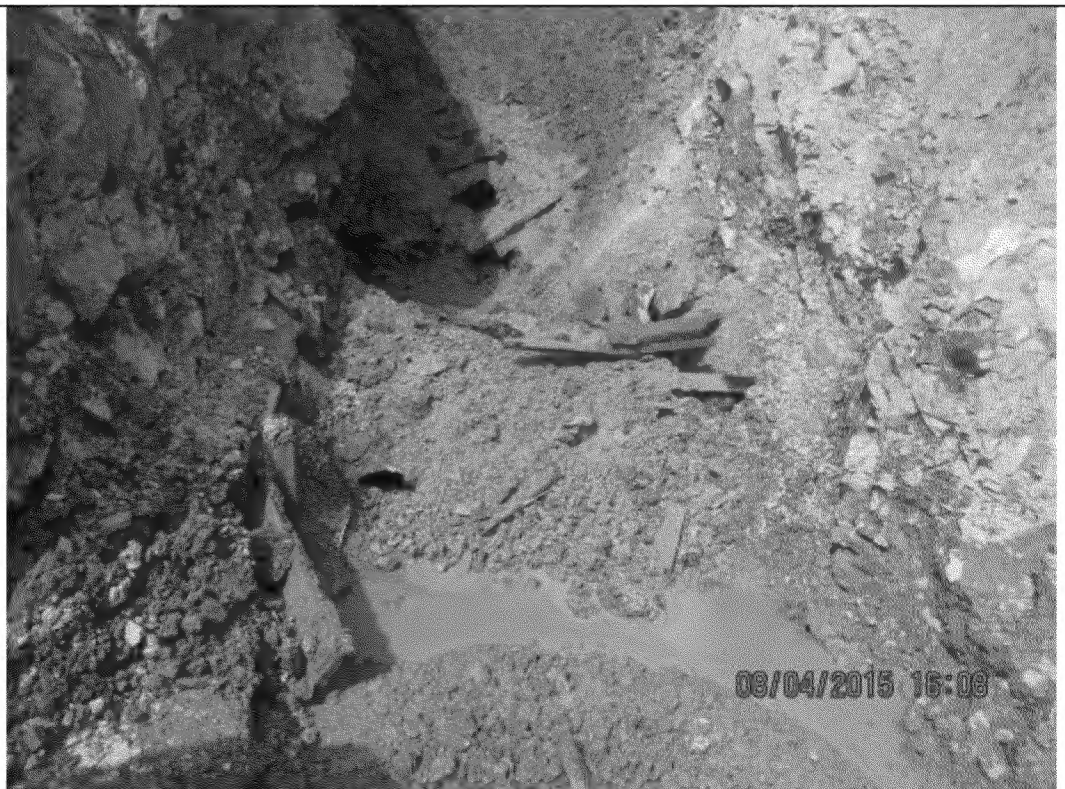
**12**

Collapsed supports uncovered above anticipated adit, no sign of bedrock above the adit area.

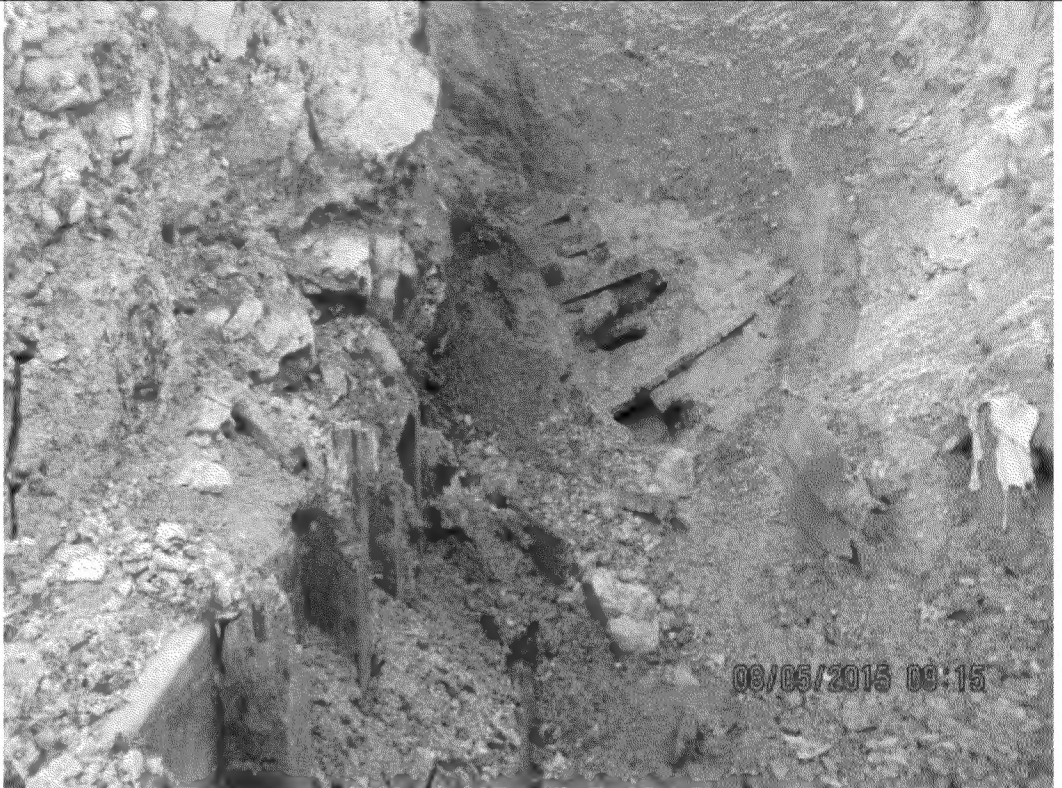
| <b>Photo No.</b><br>13 | <b>Date:</b><br>08/05/2015 | |

| <b>Description:</b><br>Adit conditions the morning of 8/5. | | |

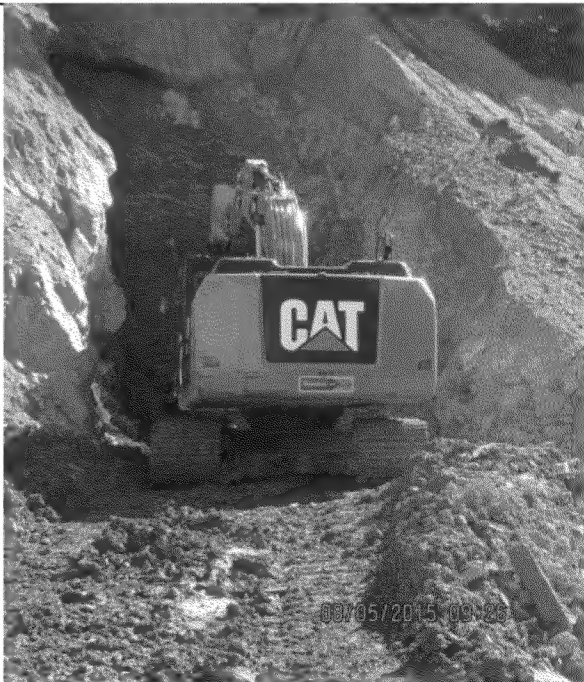
| <b>Photo No.</b><br>14 | <b>Date:</b><br>08/05/2015 | |

| <b>Description:</b><br>Excavating material above the collapsed adit. | | |

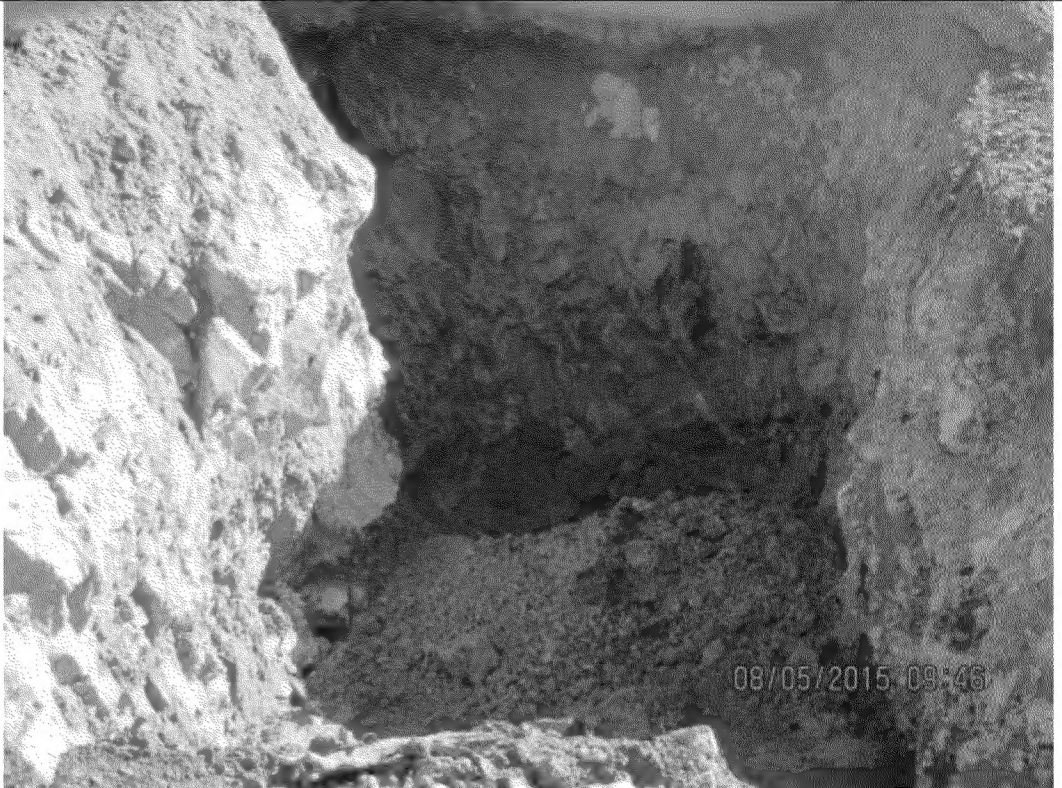
| <b>Photo No.</b><br>15 | <b>Date:</b><br>08/05/2015 | |

| <b>Description:</b><br>Bedrock found above the anticipated adit. | | |

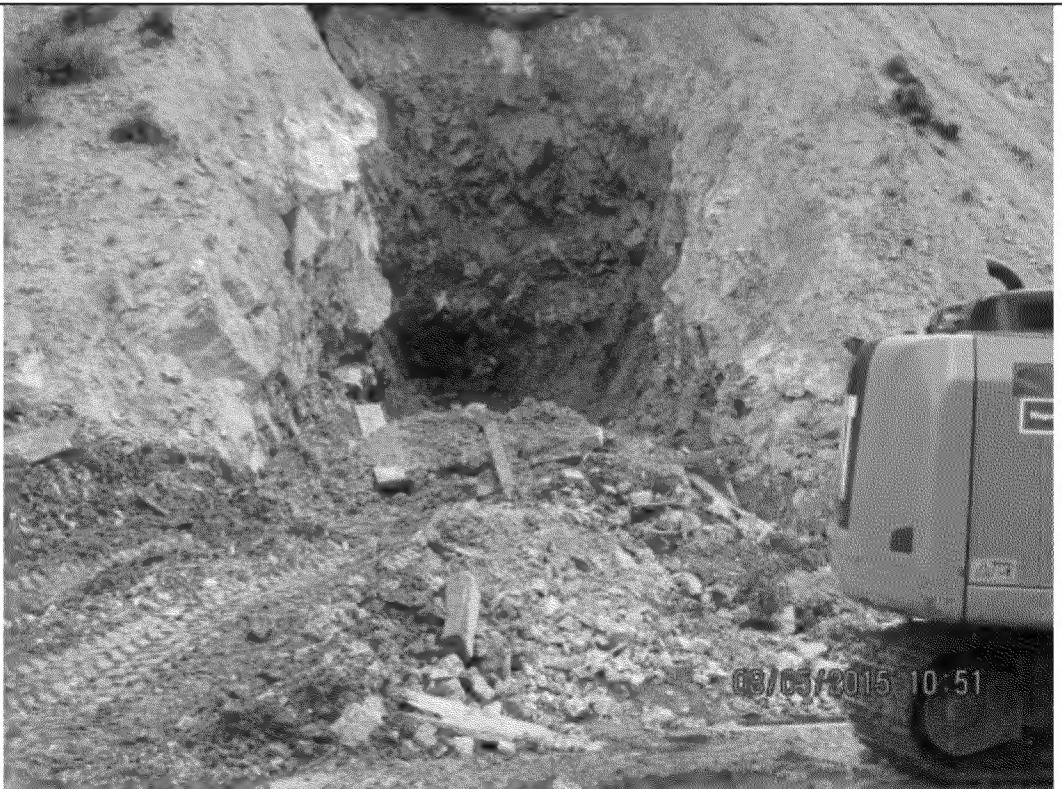
| <b>Photo No.</b><br>16 | <b>Date:</b><br>08/05/2015 | |

| <b>Description:</b><br>Cleaning out excavated material, small leak. | | |

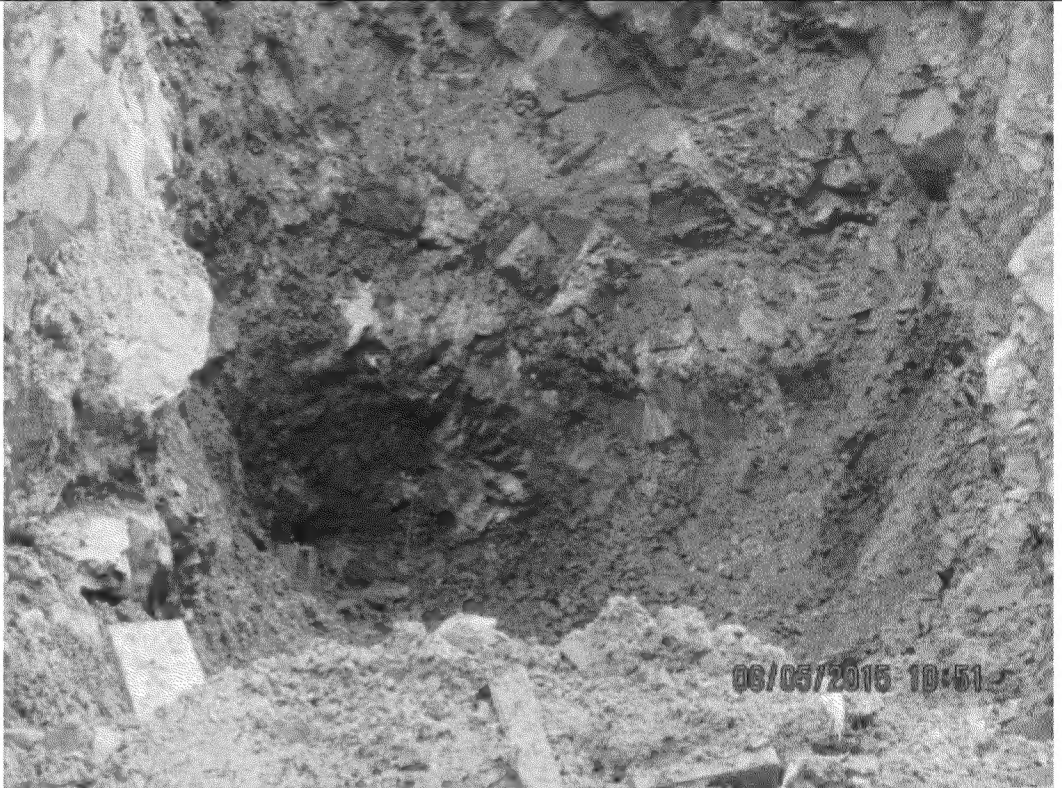
| <b>Photo No.</b><br>17 | <b>Date:</b><br>08/05/2015 | |

| <b>Description:</b><br>Small leak close up. | | |

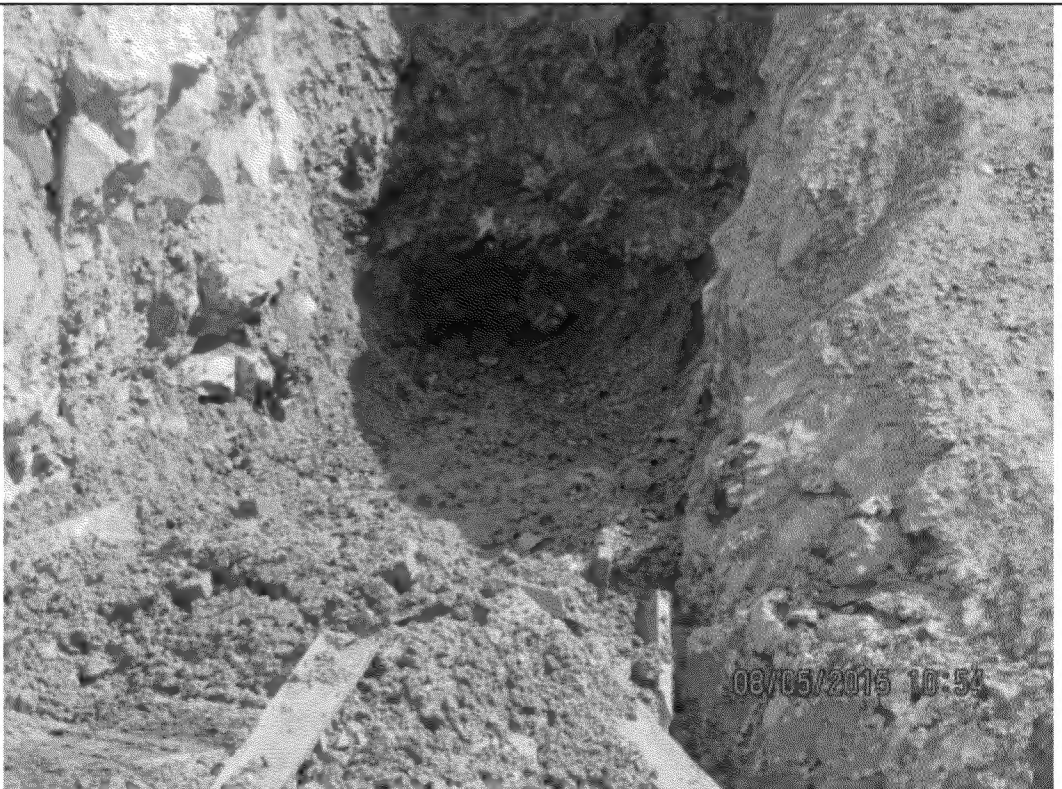
| <b>Photo No.</b><br>18 | <b>Date:</b><br>08/05/2015 | |

| <b>Description:</b><br>Hole starting to give way to flow. | | |

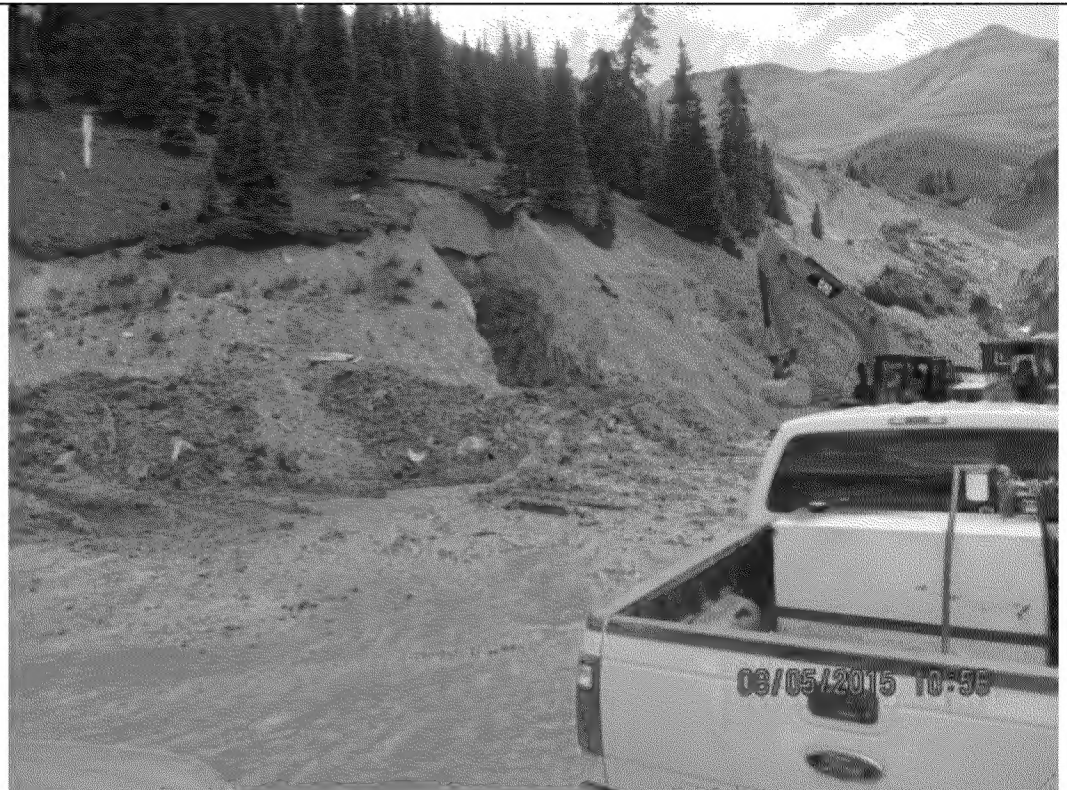
**Photo  
No.  
19**

Adit flow increasing.

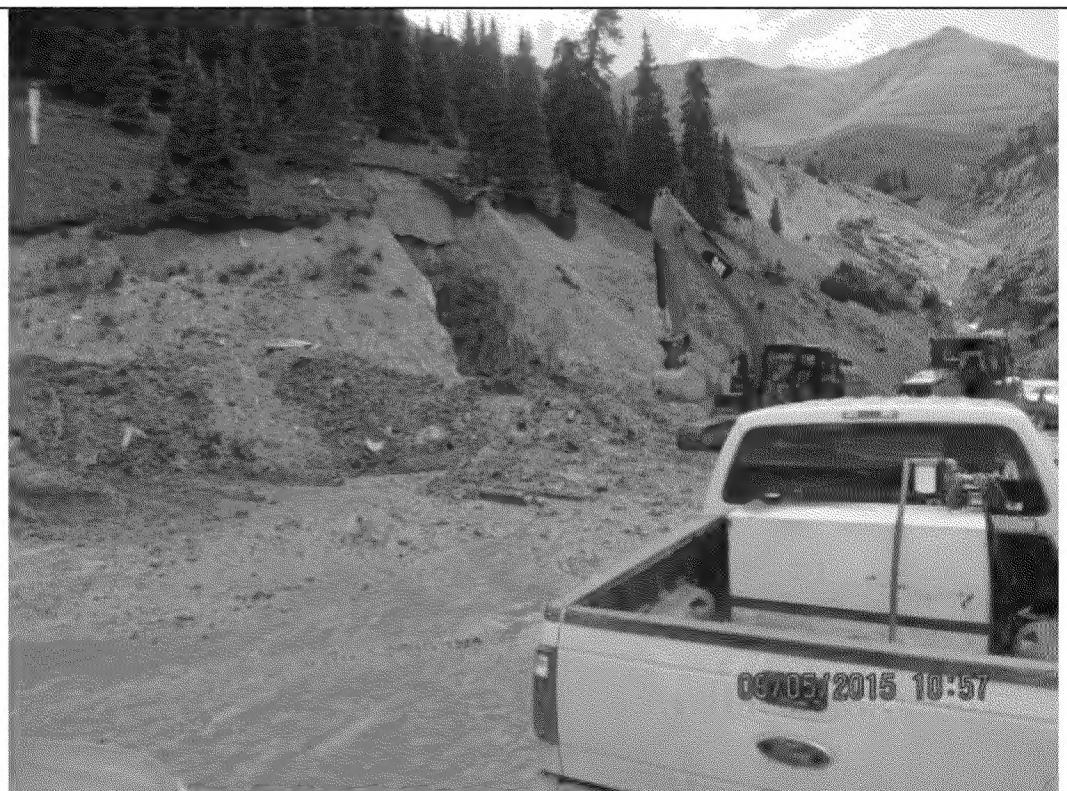
**Photo  
No.  
20**

Water flooding out at  
increased rate.

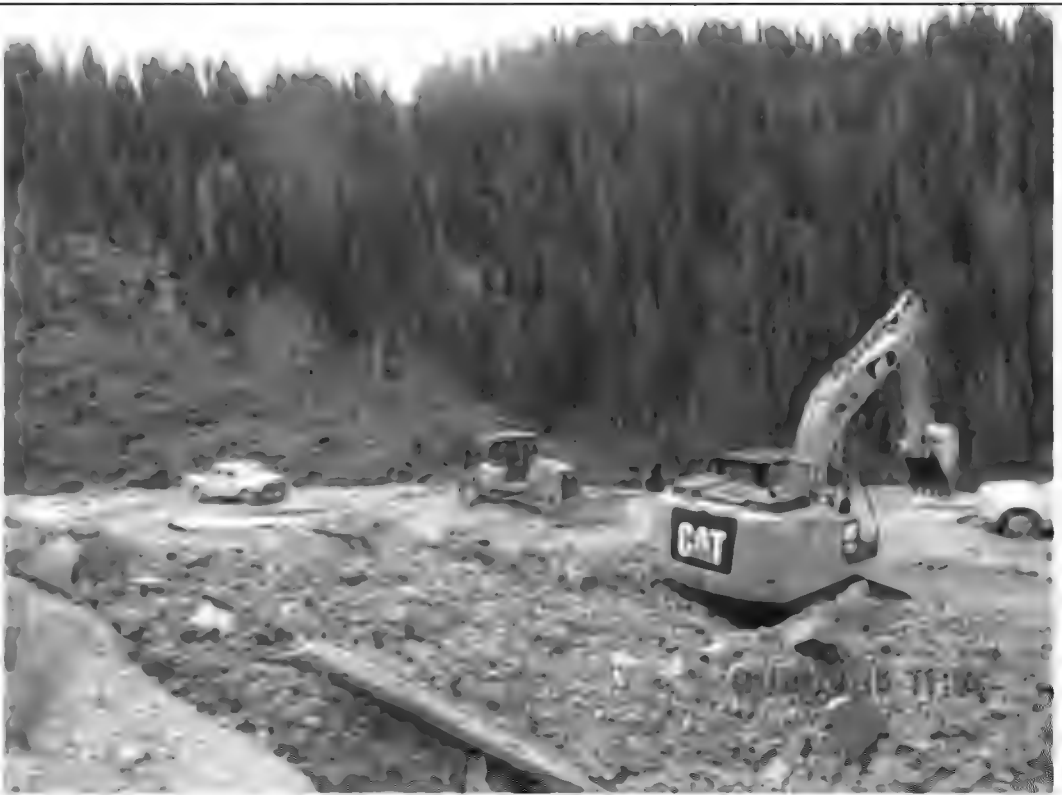
| <b>Photo No.</b><br>22 | <b>Date:</b><br>08/05/2015 | |

| <b>Description:</b><br>Water flowing over the edge of the waste dump and collapsing the edge | | |

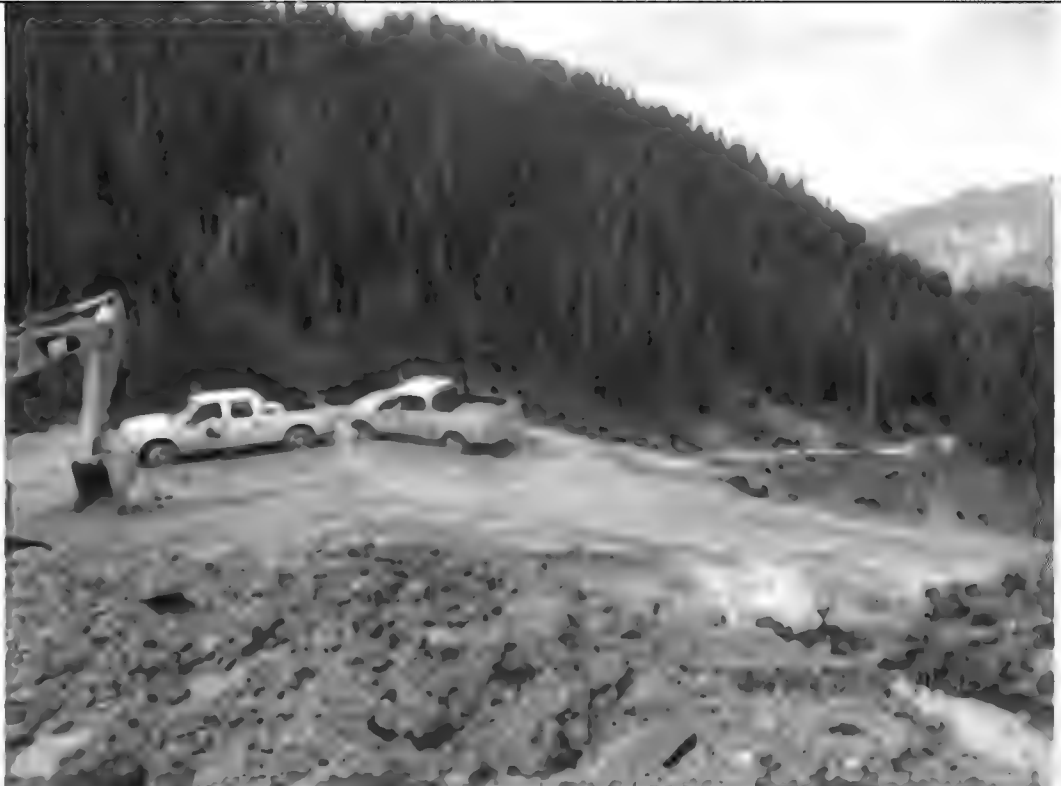
| <b>Photo No.</b><br><b>23</b> | <b>Date:</b><br>08/05/2015 | |

| <b>Description:</b><br>Exit route starting to collapse | | |

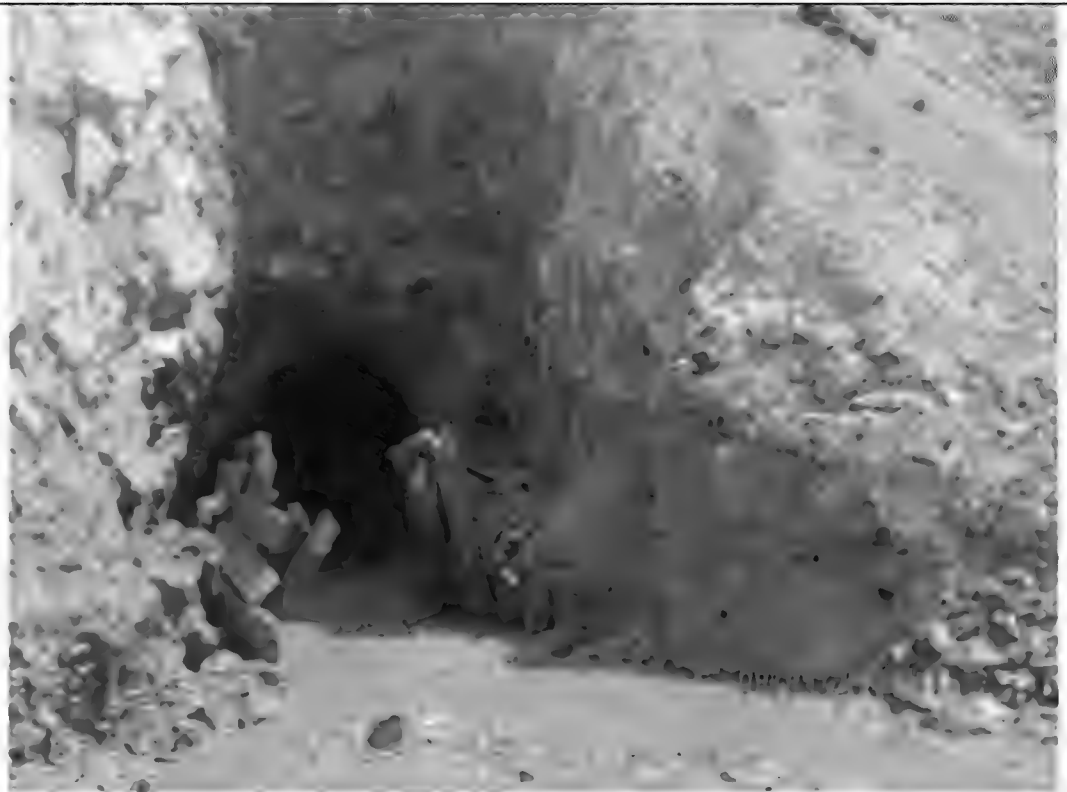
**Photo  
No.  
27**

Exposed adit, roughly  
10 feet wide by 15 feet  
high.

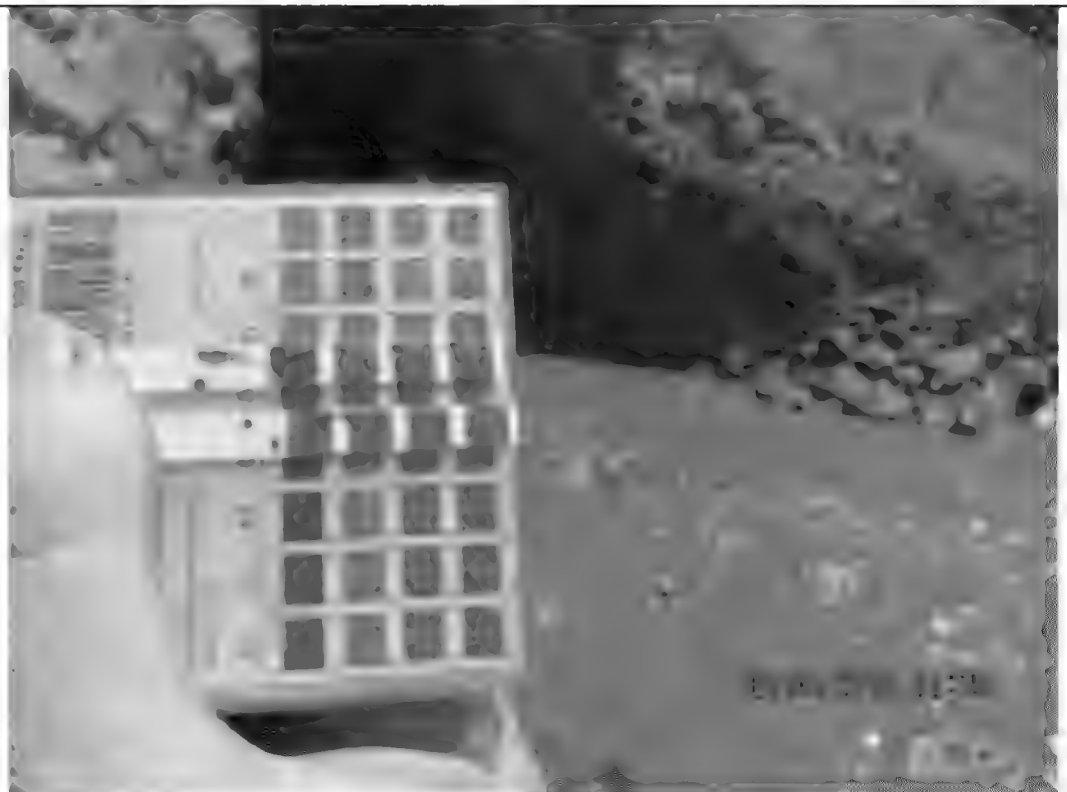
**Photo  
No.  
28**

pH of discharge water  
is approximately 4 to  
4.5.

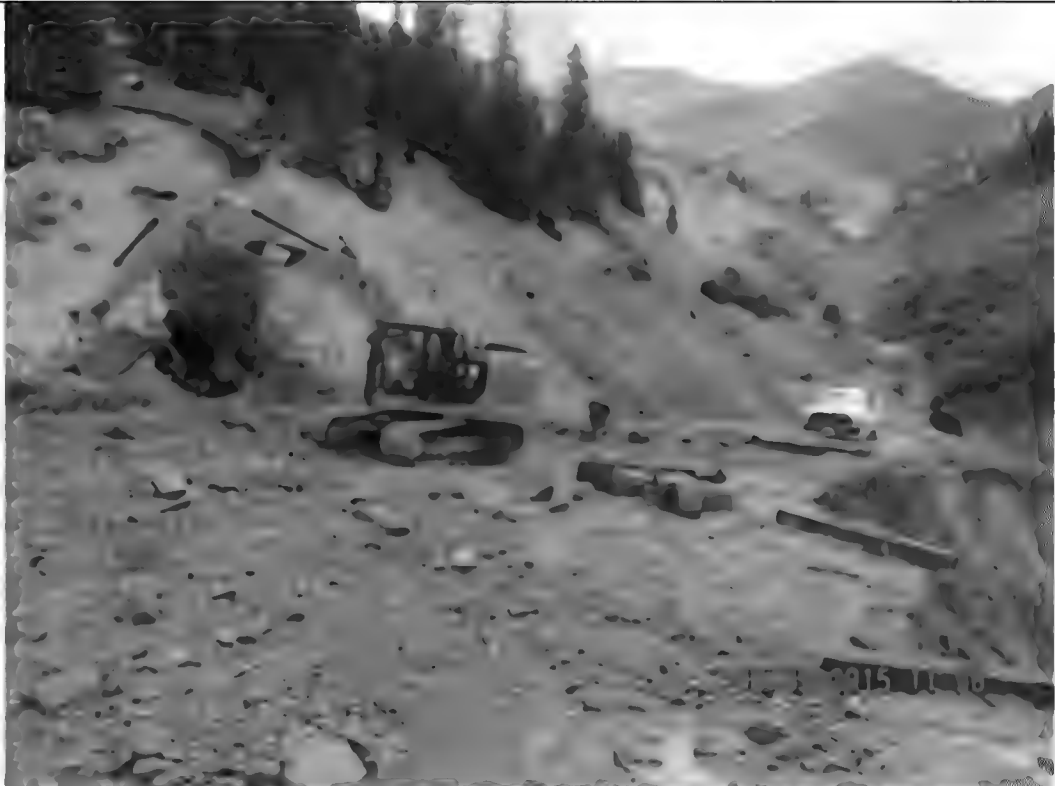
| <b>Photo No.</b><br><b>29</b> | <b>Date:</b><br>08/05/2015 | |

| <b>Description:</b><br>Excavator redirecting water into existing half-pipe channel. | | |

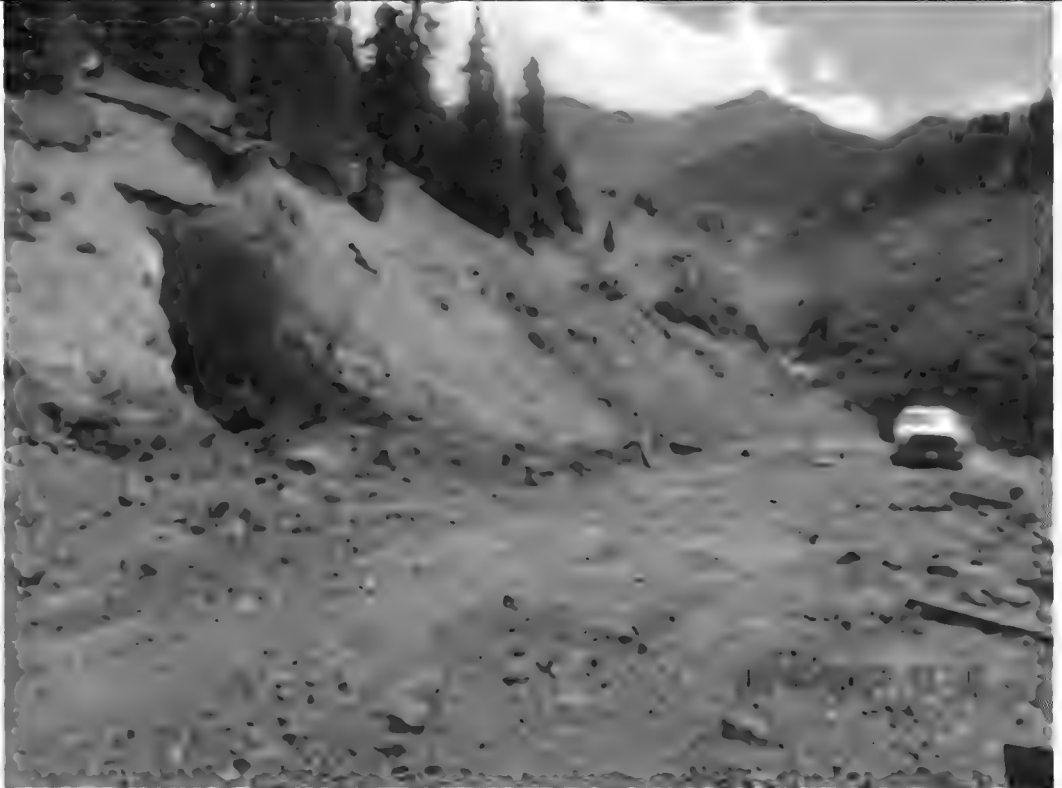
| <b>Photo No.</b><br>31 | <b>Date:</b><br>08/05/2015 | |

| <b>Description:</b><br>Adit area after regrading. | | |

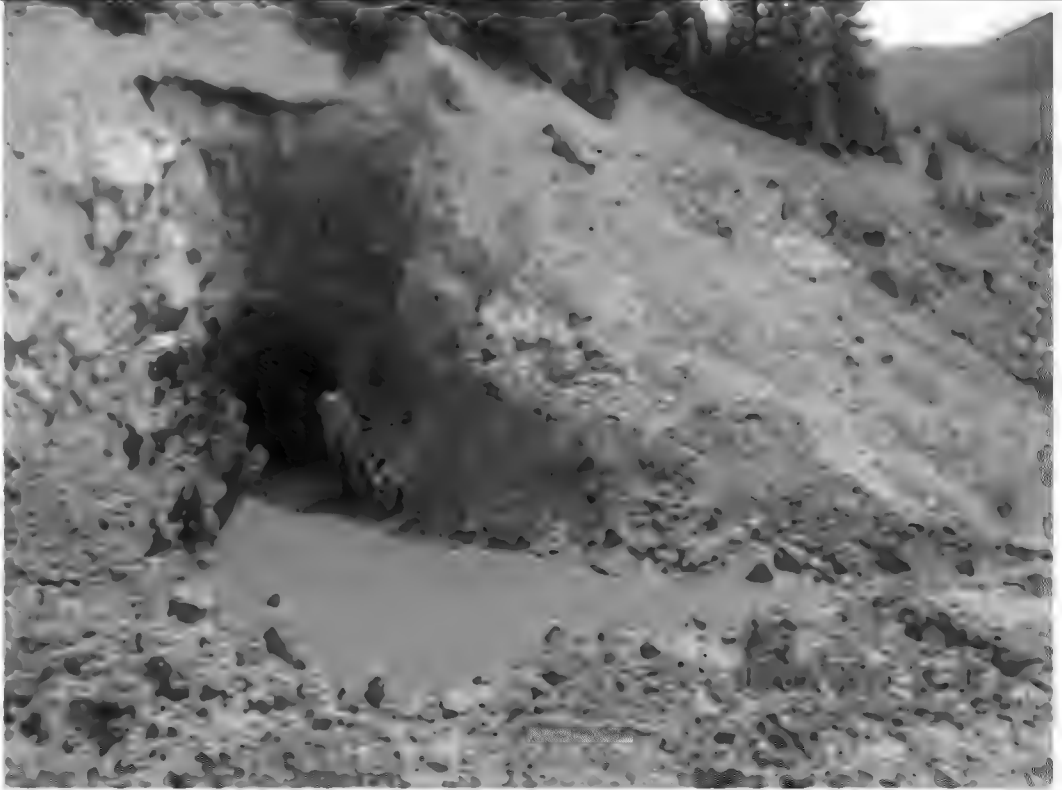
| <b>Photo No.</b><br>32 | <b>Date:</b><br>08/05/2015 | |

| <b>Description:</b><br>Exposed adit and redirected flow, flow is beginning to subside. | | |
